Locomotive 3463 Move Preparation Report

The Coalition for Sustainable Rail (CSR) sent a work crew to Topeka, Kansas in June 2013 to prepare its steam locomotive number 3463 for its first substantial move in 57 years. The locomotive was placed in the park with a dedication ceremony on November 3, 1956. It sat parallel to Topeka Avenue until the mid 1980's when, as the Kansas Expocentre was being constructed, the locomotive was moved roughly 500 feet downhill and away from the main road.

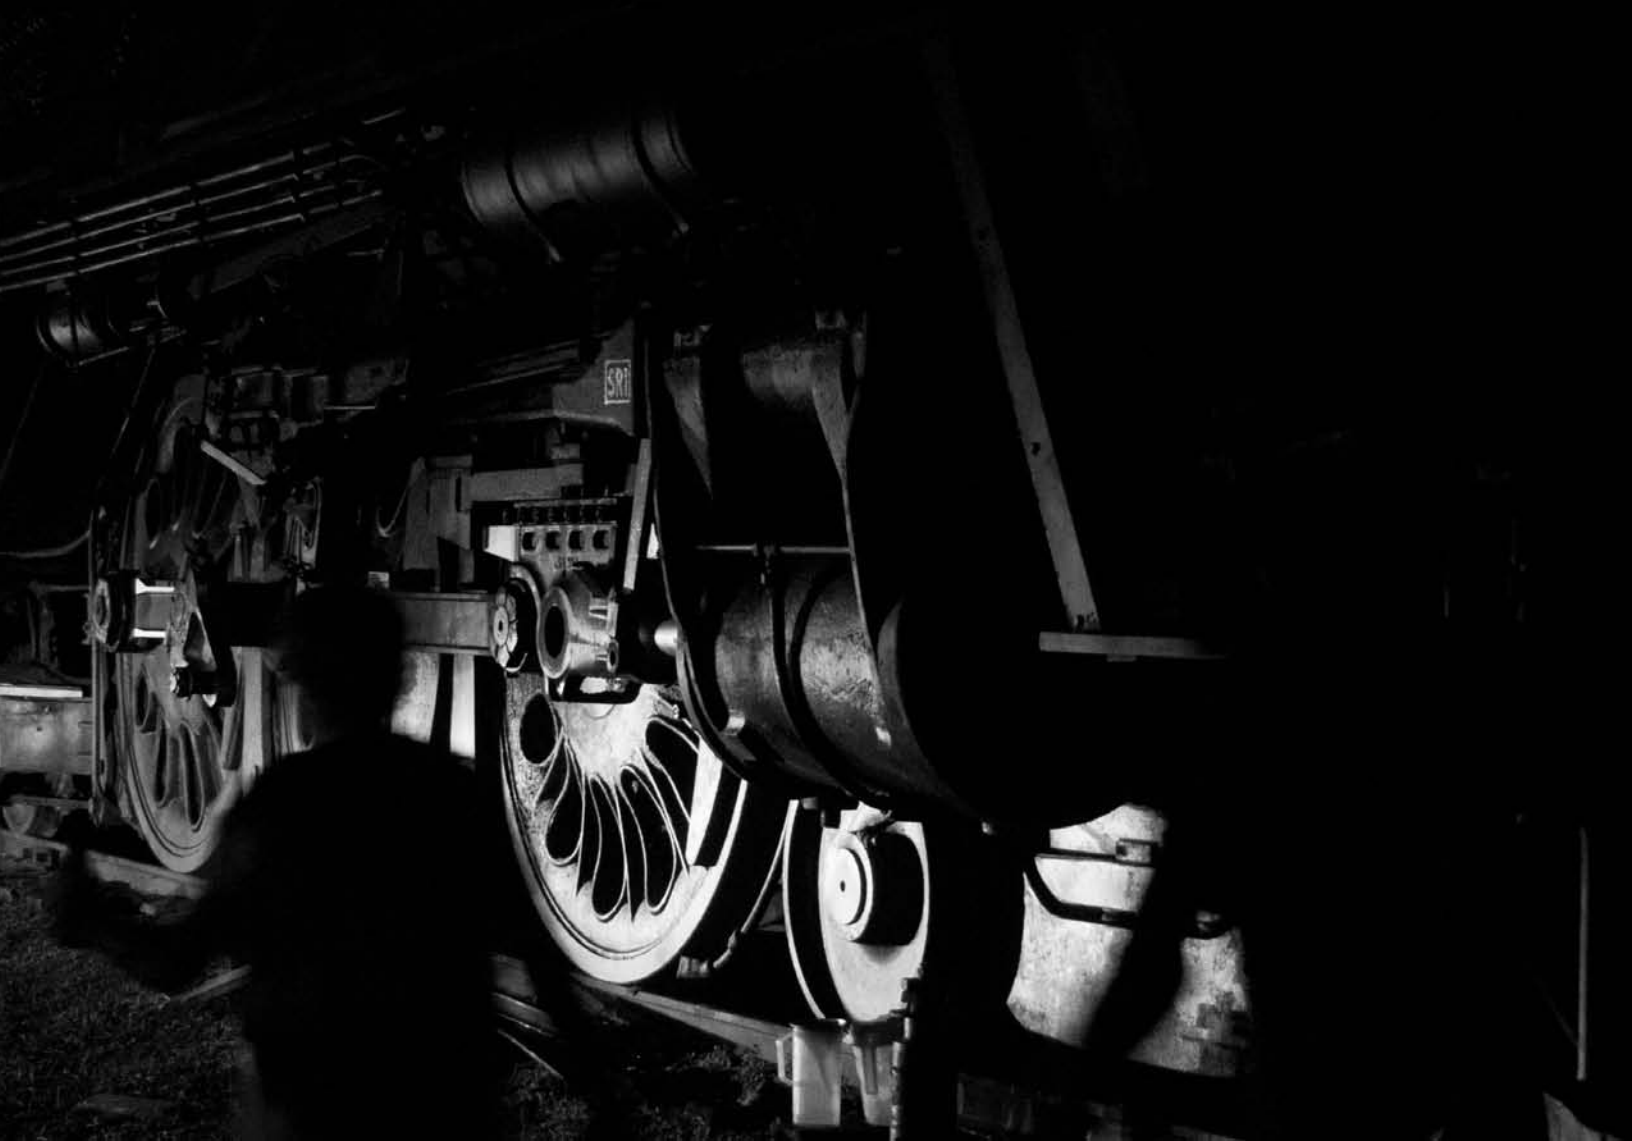
Cover Photo - CSR Technical Advisor Ing. Wolf Fengler walks in front of 3463's 84" driving wheels on a late night work session. The locomotive's main rods have been removed and placed on the running boards in this photo and all axle roller bearings have been inspected and cleaned.

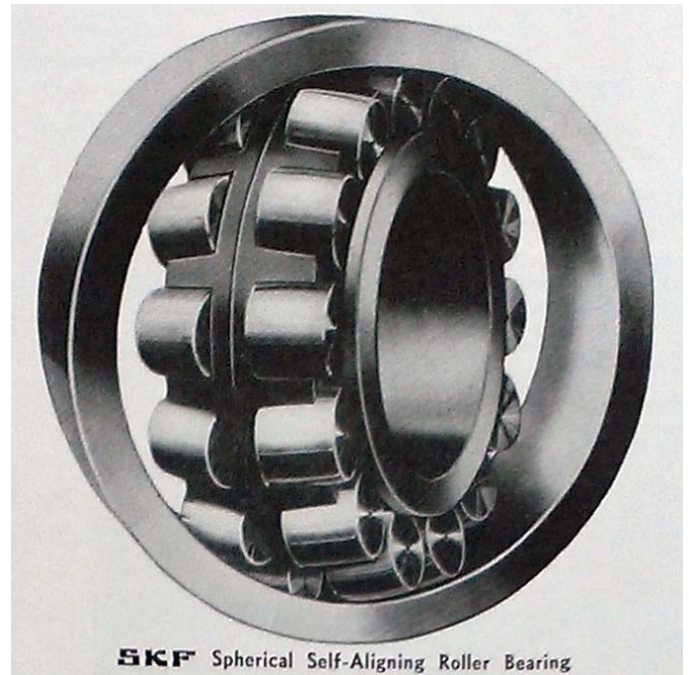
Where a roller meets the sphere: This skewed view of the SKF-designed spherical roller bearing illustrates its cross section quite clearly.

Invented by Swedish company SKF, the spherical roller bearing has many similar attributes to those of the tapered roller bearing, but features greater resilience in the face of misalignment and flexing of axles under stress. According to the company: Spherical roller bearings have two rows of rollers, a common sphered

outer ring raceway and two inner ring raceways inclined at an angle to the bearing axis. The bearings are self-aligning and insensitive to misalignment of the shaft relative to the housing, which can be caused, for example, by shaft deflection. Spherical roller bearings are designed to accommodate heavy radial loads, as well as heavy axial loads in both directions.

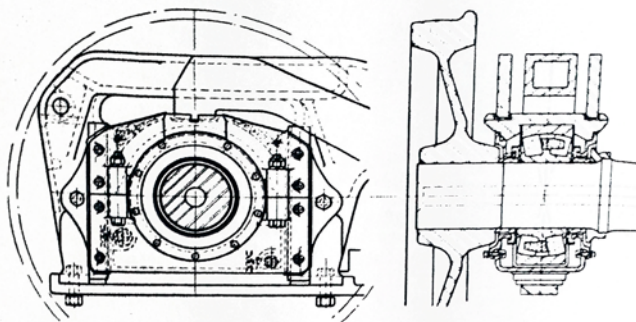
Fig. 8.311—Engine truck journal assembly of SKF spherical journal bearings.

Bearing Box Design: Taken from the 1941 locomotive cyclopedia, this drawing shows cross sections through SKF lead and trailing truck axes boxes, as used on locomotive 3463.

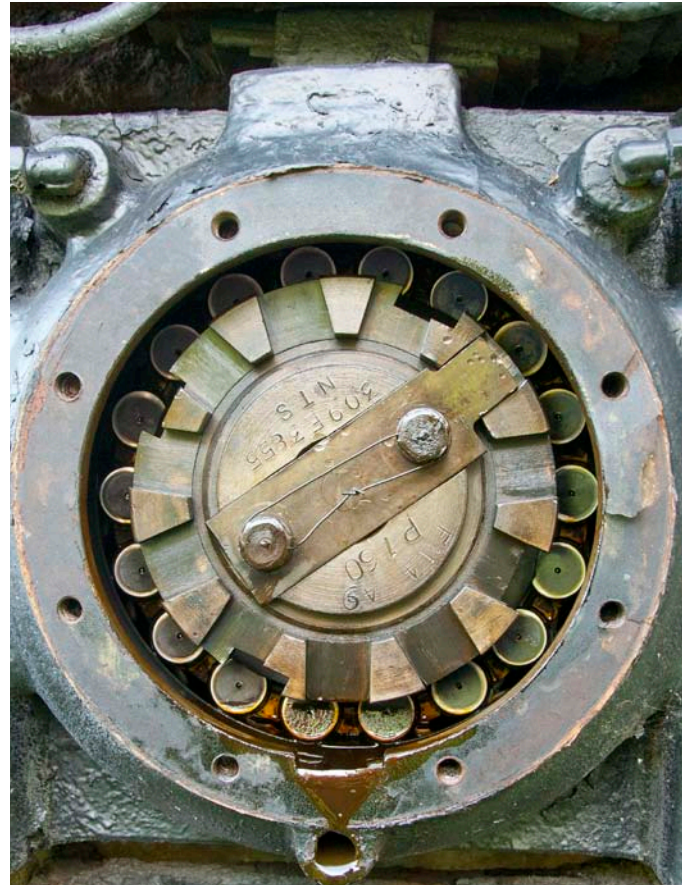
Shine with a paper seal: When crews opened the trailing truck axle boxes, they were surprised with clean, rust-free bearings.

Beginning with easy-to-access trailing truck bearings, CSR began draining the half-century old bearing oil, which flowed out of the drain plug with little difficulty. Once flow waned to a trickle, the CSR crew unbolted the cast bearing covers and removed them. Unsure what to expect, CSR discovered bearings in shockingly good condition considering the total lack of maintenance. Seeing no visible pitting on any of the bearings and little contaminant in the oil, the CSR crew went about draining the remainder of the axles of their oil.

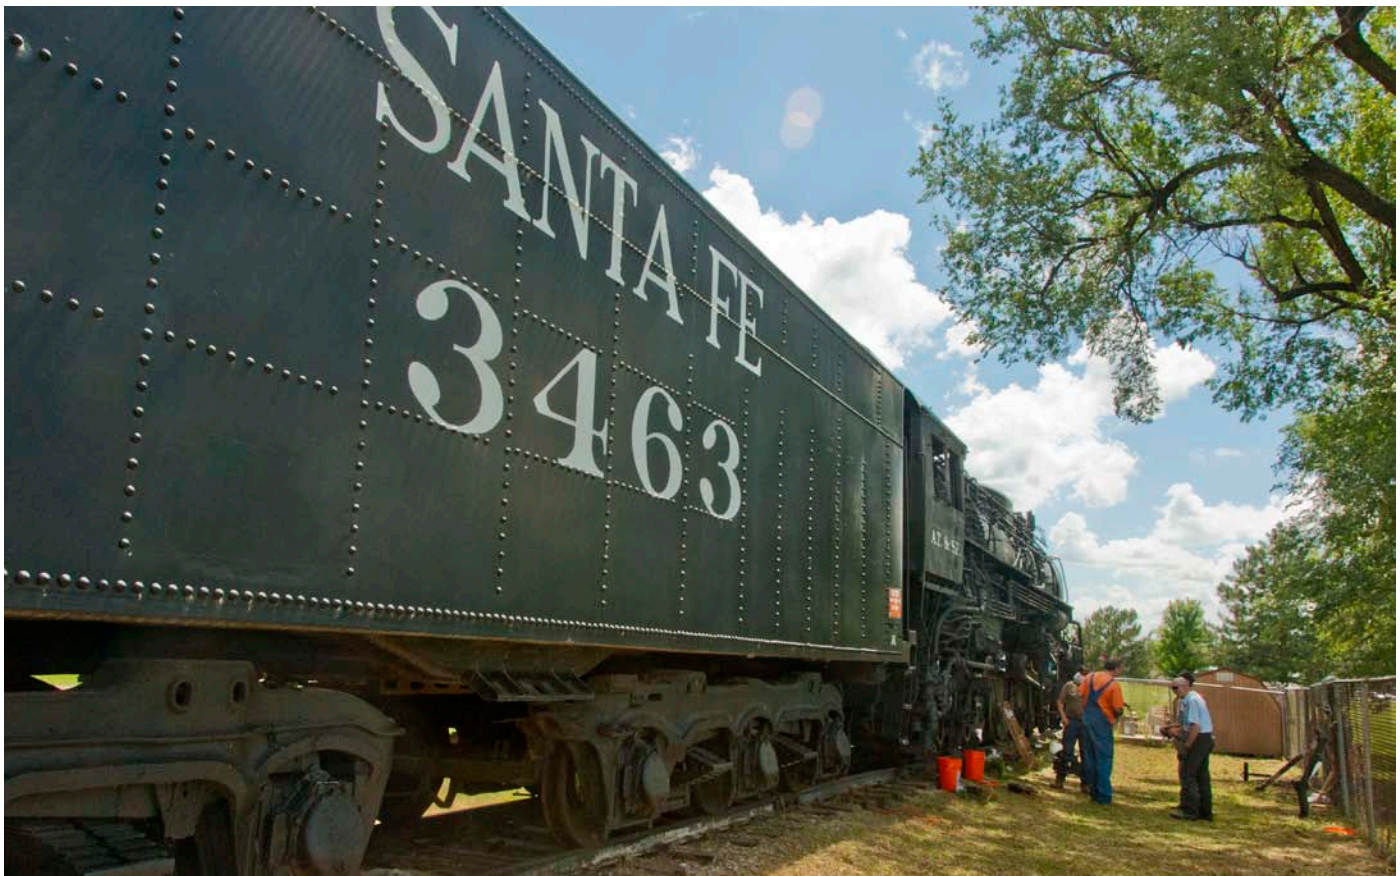
Kansas in Summer: With sun beaming down, crew members discuss next steps with the side rods following removal of the eccentric crank.

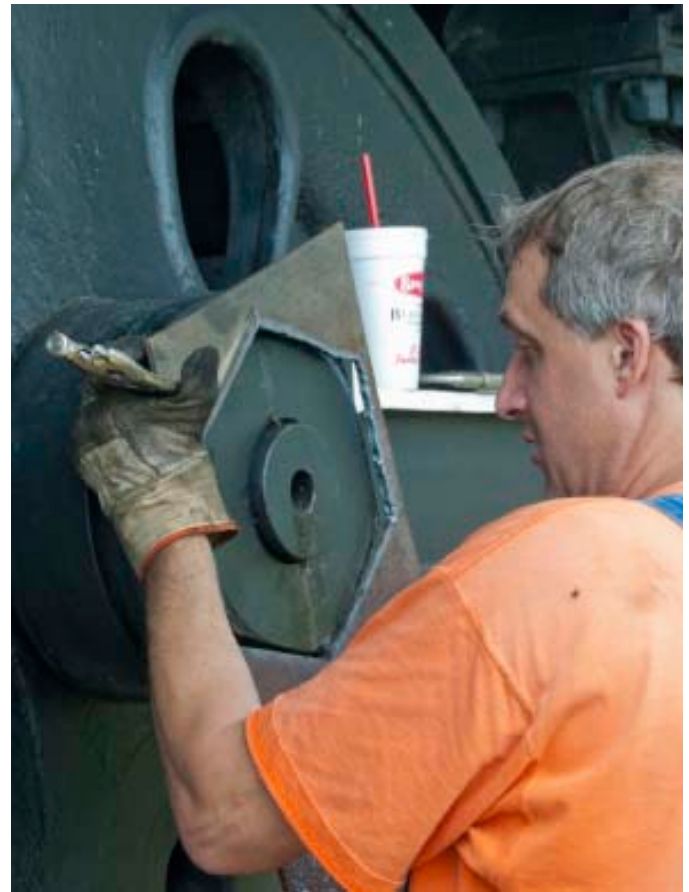
Custom Wrenches: Measured, cut and machined on-site, the 10.5" diameter nuts required one-off wrenches, one of which is rough-fit above.

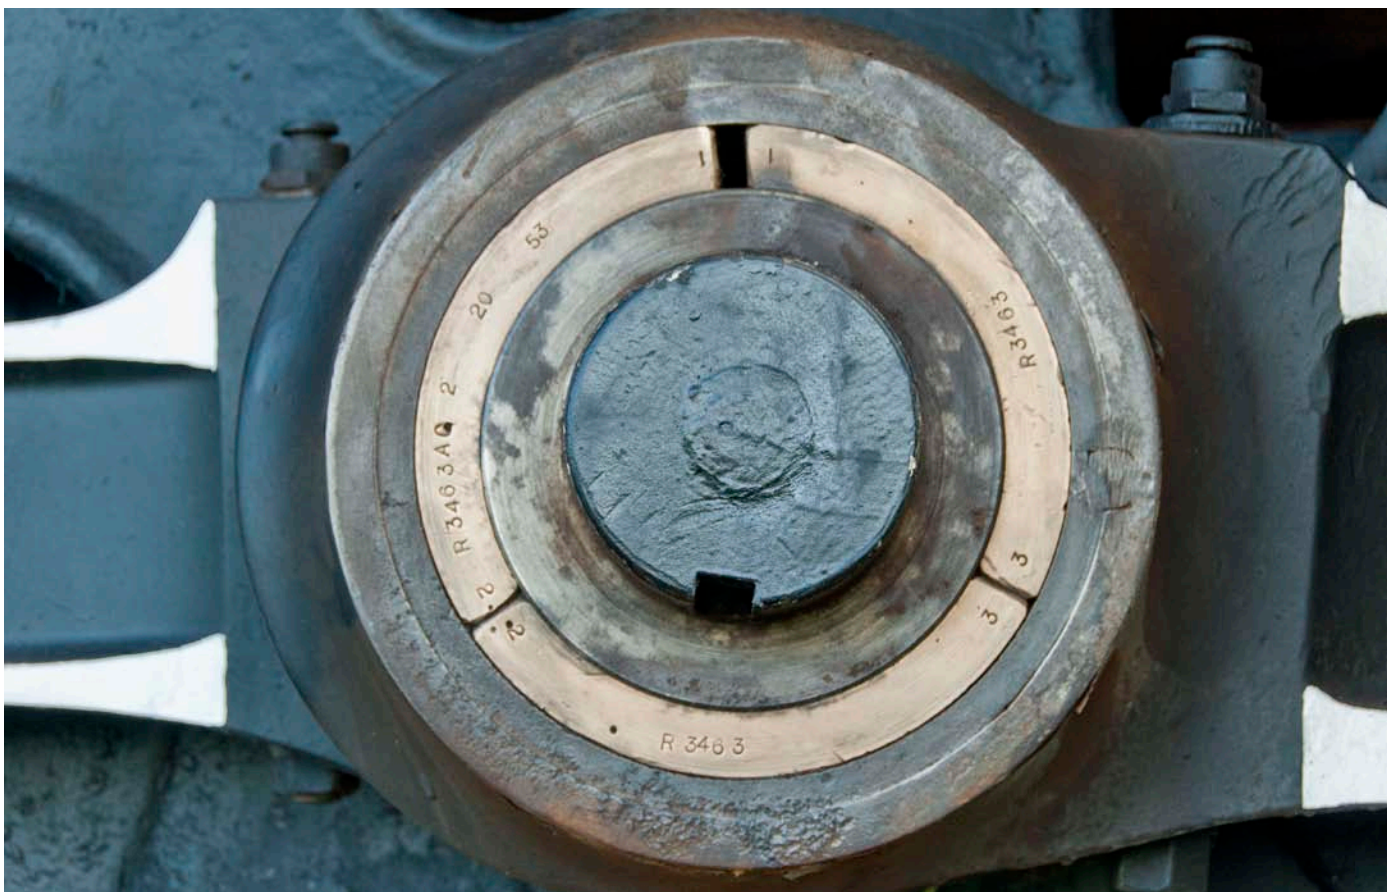
R3463 AQ 2 20 53: Punched into fresh bearings 60 years ago, those numbers indicate a set of running gear brasses fresh out of the shop. Unlike many other locomotives, 3463 features segmented brasses which feature three seams (most evident match 1:1) to accommodate expansion with heat.

being stuck into whatever park it currently sits. Though often apocryphal, in the case of 3463, it appears that is almost the case. The A.T.&S.F. maintained inspection tags and stamped parts installed on each of its steam locomotives when work was performed to maintain a detailed record of work undertaken. The near-new rod bearings exposed when crews removed the eccentric crank read: AQ 2 20 53. This is code for work performed at the Albuquerque, New Mexico shop, with brasses installed on February 20, 1953. Considering the locomotive was taken out of service in 1954 and the visual inspection of the bearings, it appears the engine has a lot of life left in it!

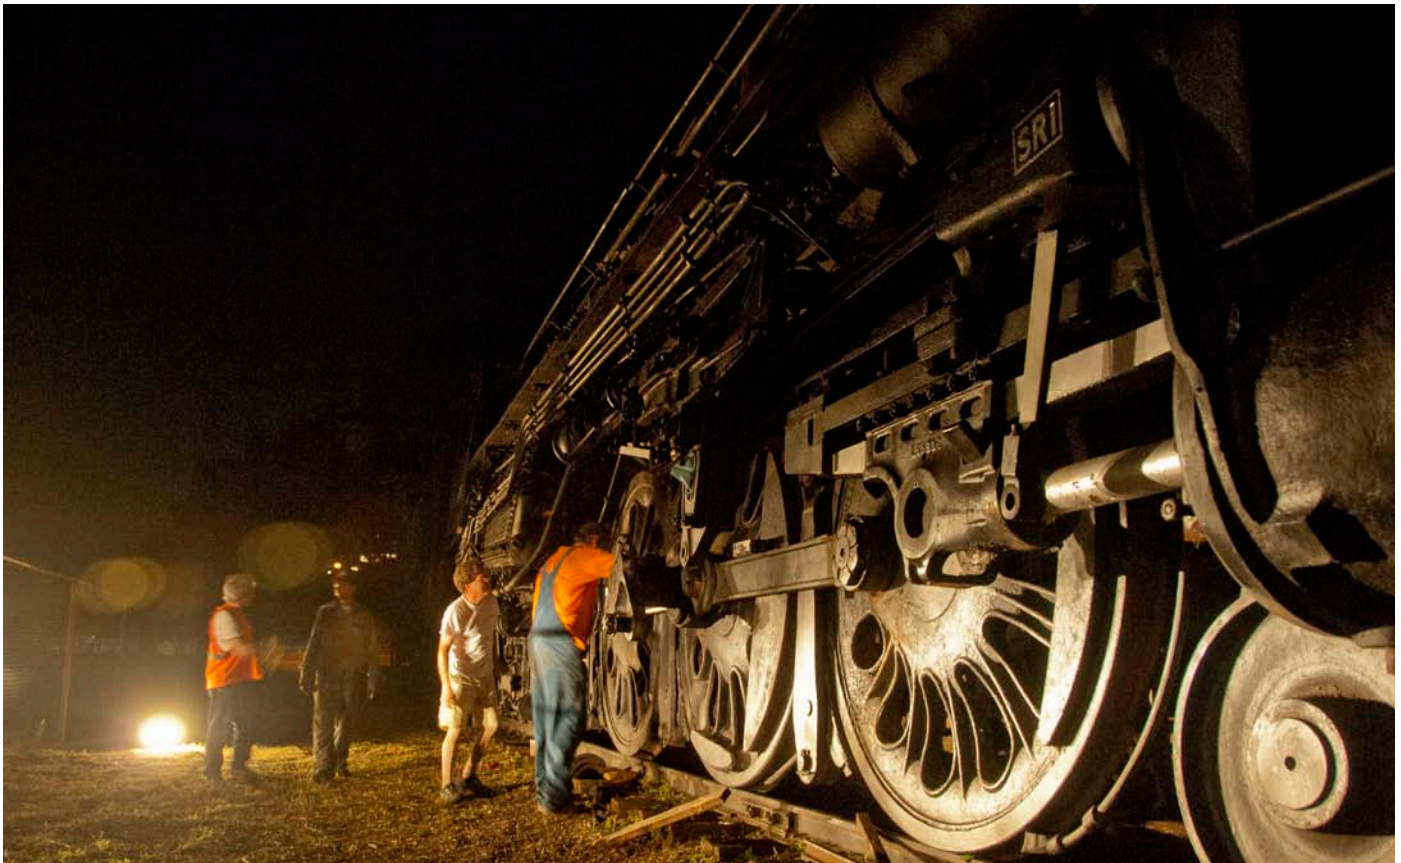
Working into the night: Illuminated by work lamps, the figure of 3463 is nothing short of imposing. The main rods have already been removed, brasses stored, eccentric cranks replaced and locomotive rolled back-and-forth by the time this image was taken.

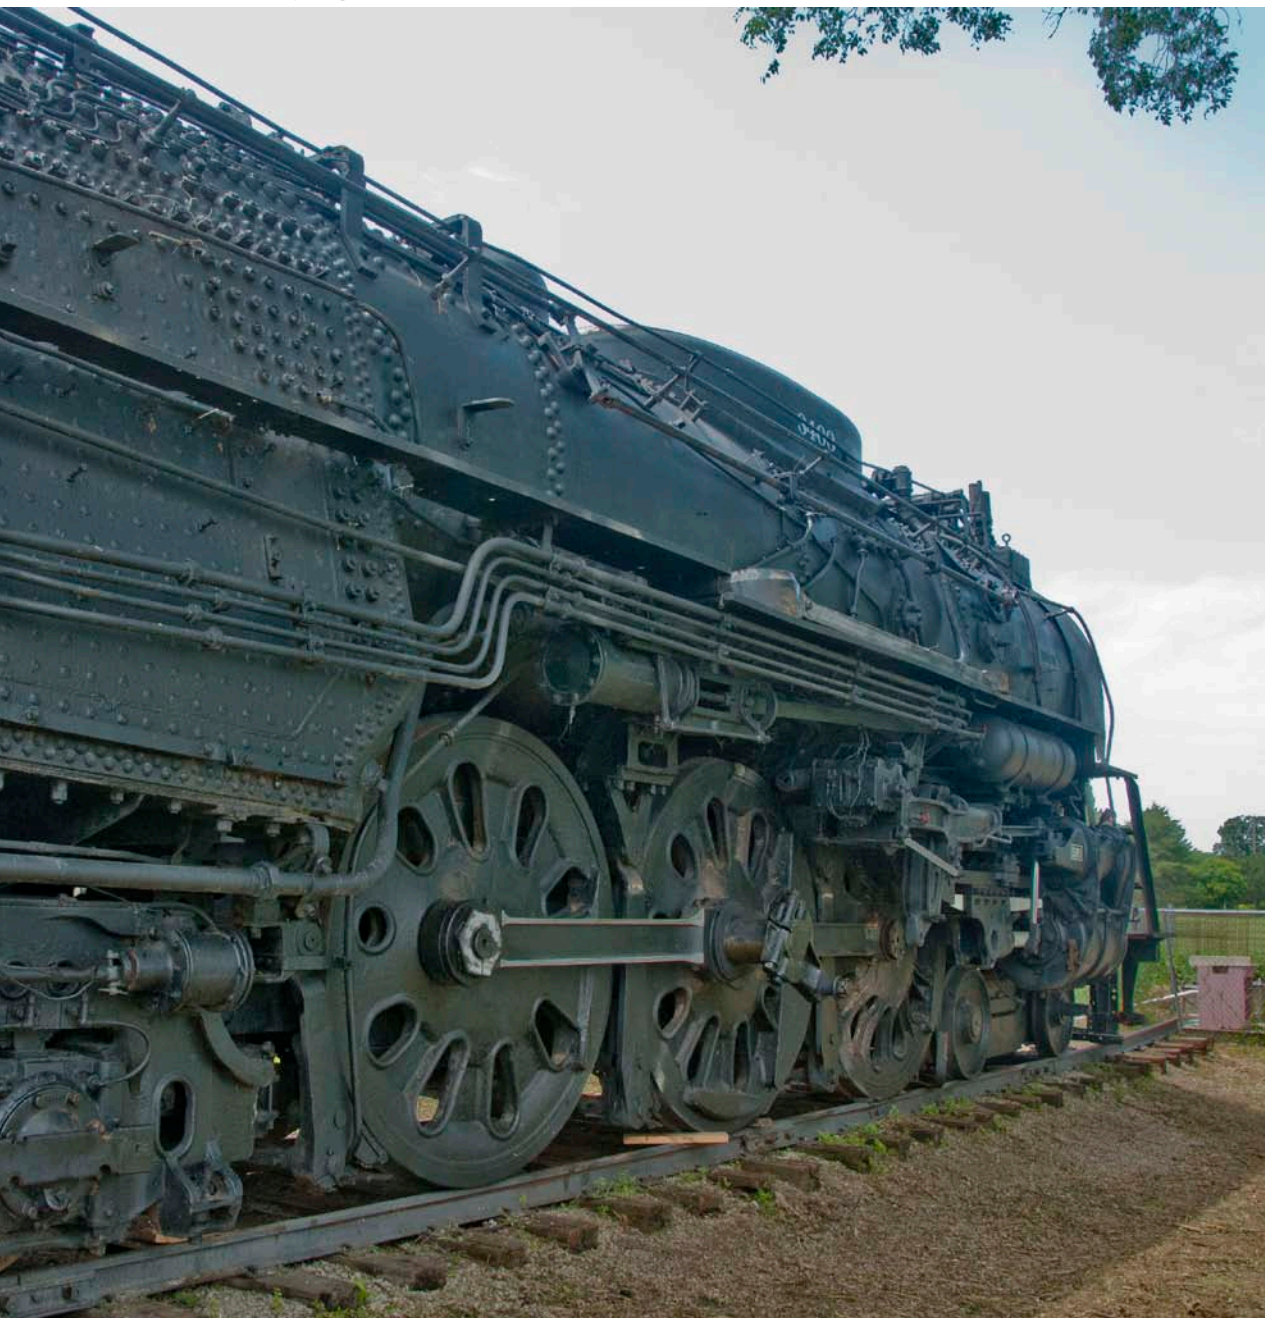
Rods up, ready to go...
